Interstate 90 – Snoqualmie Pass East

VISUAL IMPACT ASSESSMENT DISCIPLINE REPORT

September 2004

**Washington State
Department of Transportation**

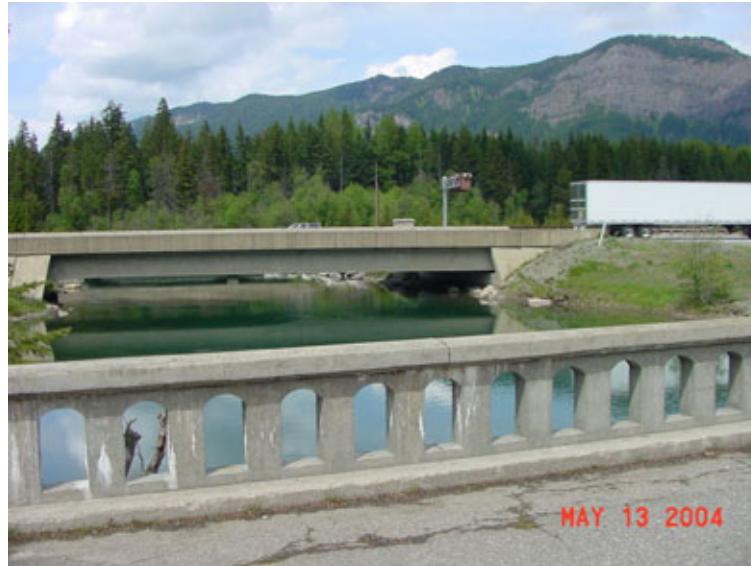
Figure 133 Key View L

This view from a popular fishing bridge has the eastbound bridge over the Kachess River in the middleground. There is only one Build Alternative at this location, widening of the bridges over the Kachess River. After construction, visual quality from this location is expected to remain equal to existing conditions through use of the Architectural Guidelines and revegetation.

This is a partial view of Lake Easton. (Water levels were low in the Fall of 2001 when the photo in Figure 132 was taken.) The project will widen the bridge over the Kachess River using the Architectural Guidelines for all elements of the bridge. This is a highly visible bridge, as seen in Key View L, Figure 133. After project completion, visual quality ratings will remain equal to the existing condition (see Table 32). Although there will be an additional lane, the use of a consistent design theme on structures and revegetation will provide corridor continuity and make this section of I-90 more memorable.

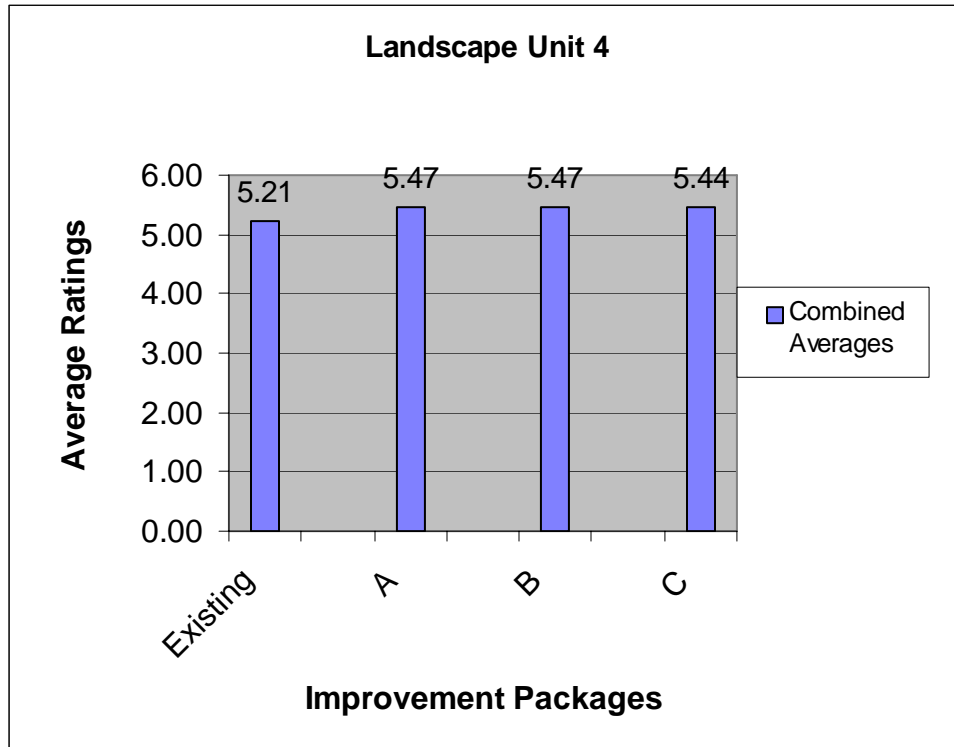
Figure 134 Landscape Unit 4 – Improvement Package Ratings

Figure 134 shows a comparison of the averages of total visual quality ratings for Key Views 15, 16, and 17, which show the Improvement Packages in Landscape Unit 4. Improvement Package A and B have equivalent visual quality ratings. All build alternatives have higher total visual quality ratings than the existing condition. Visual quality will remain high after project completion.

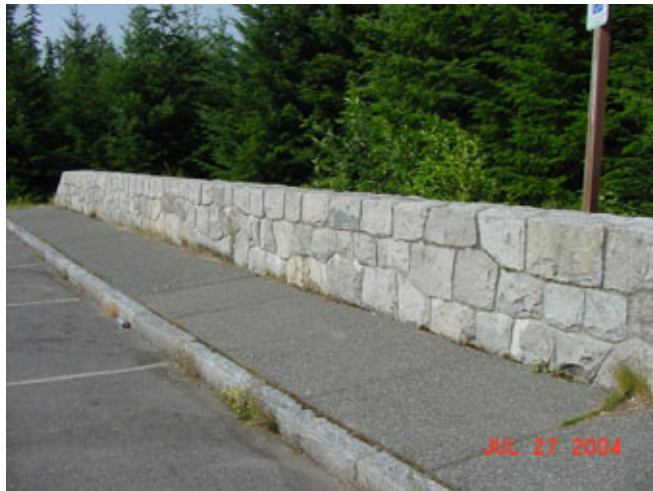
Figure 135 Example of Cascadian Theme Wall

Architectural structures, such as bridge piers and railing, bridge abutments, tunnel portals, retaining walls, traffic barriers, and light standards will carry a Cascadian theme, where possible, throughout the project corridor. The Cascadian Theme uses native stone, or concrete forms that simulate native stone, and arches. A similar treatment that has been used at Mount Rainier National Park is seen in Figure 135.

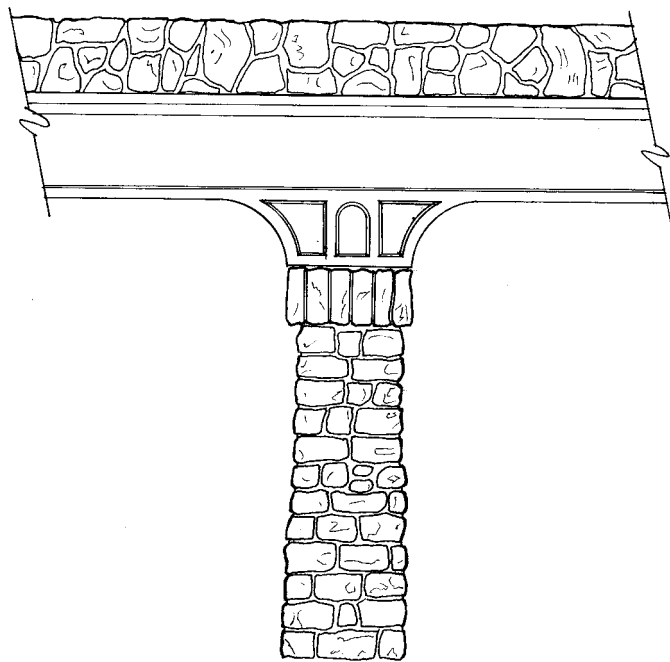
Figure 136 Bridge Pier and Railing with Cascadian Design Theme

Figure 136 shows a bridge pier and railing designed with the application of the Cascadian theme, using natural stone or the appearance of native stone and arches where applicable.

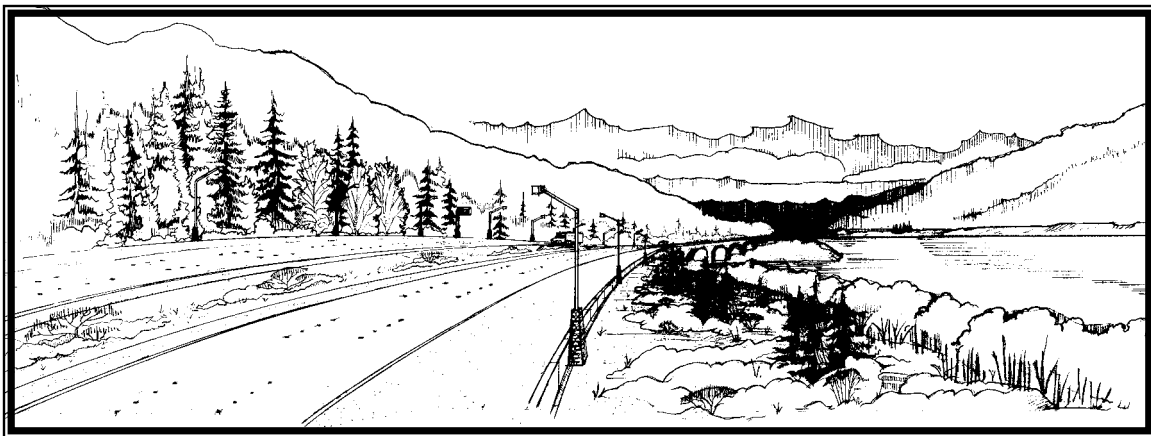
Figure 137 Key View 2 Concept

To minimize adverse impacts from lighting (glare) associated with luminaires, directed lighting will be used. Luminaire standards found in WSDOT's *Design Manual*, Chapter 840 are directional and meet project goals. The sketch in Figure 137 shows an artist's concept of luminaires along the chain-off area in the vicinity of MP 56.

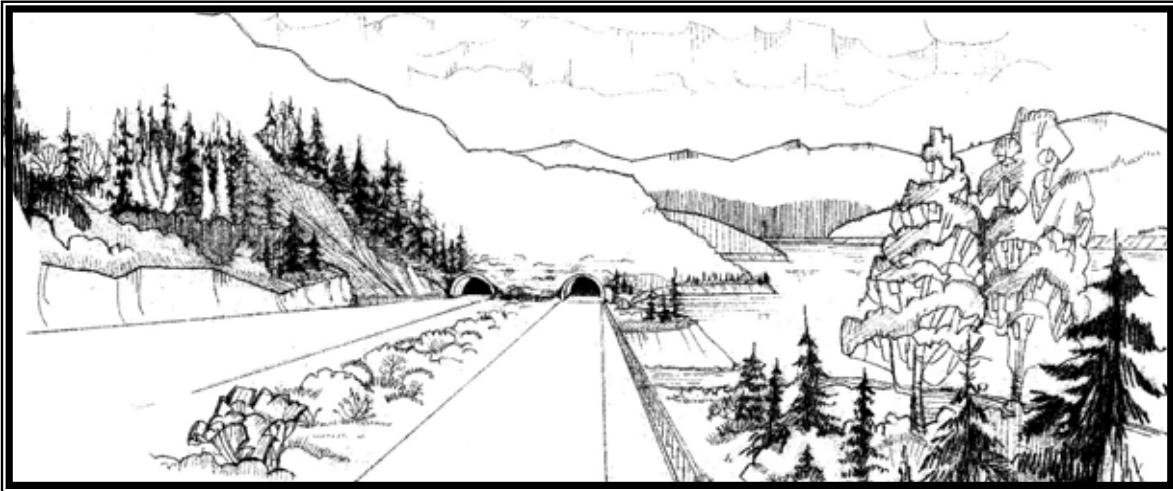
Figure 138 Key View 3 Concept

The tunnel portals and any associated structures, such as ventilation housing and maintenance facilities, should be designed according to the Architectural Guidelines with a Cascadian theme. Lighting inside the tunnel should provide glare-free illumination. Figure 138 depicts the concept

for Key View 3. Tunnels portals may have a headwall of native stone or simulated stone to carry the Cascadian theme.

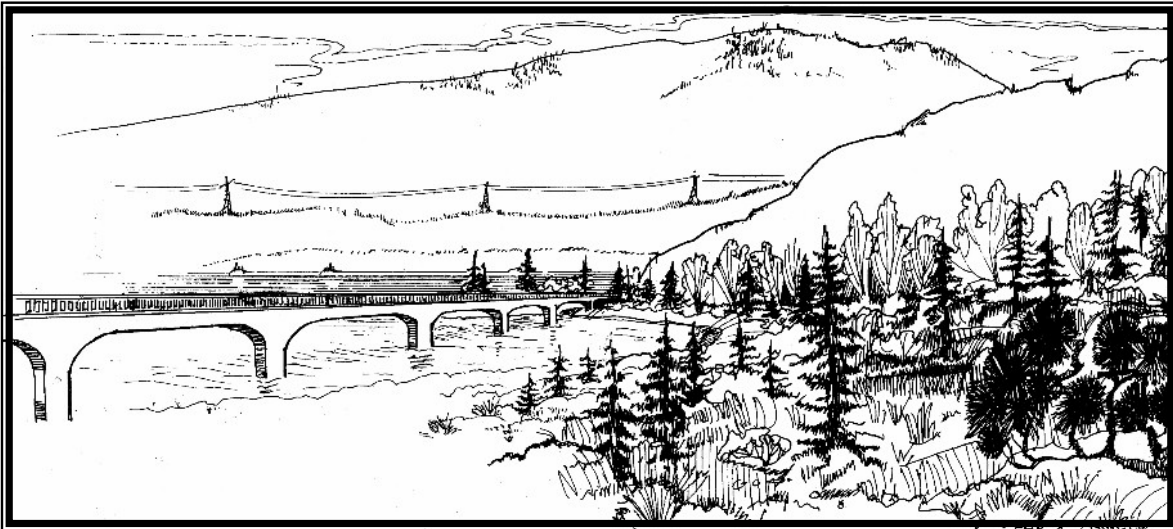
Figure 139 Typical Design Concept for Multi-Span Bridges

High visibility bridges will be designed with an arch as seen in Figure 139. This is in accordance with the Architectural Guidelines. This sketch shows a railing, but patterned barriers may also be used.

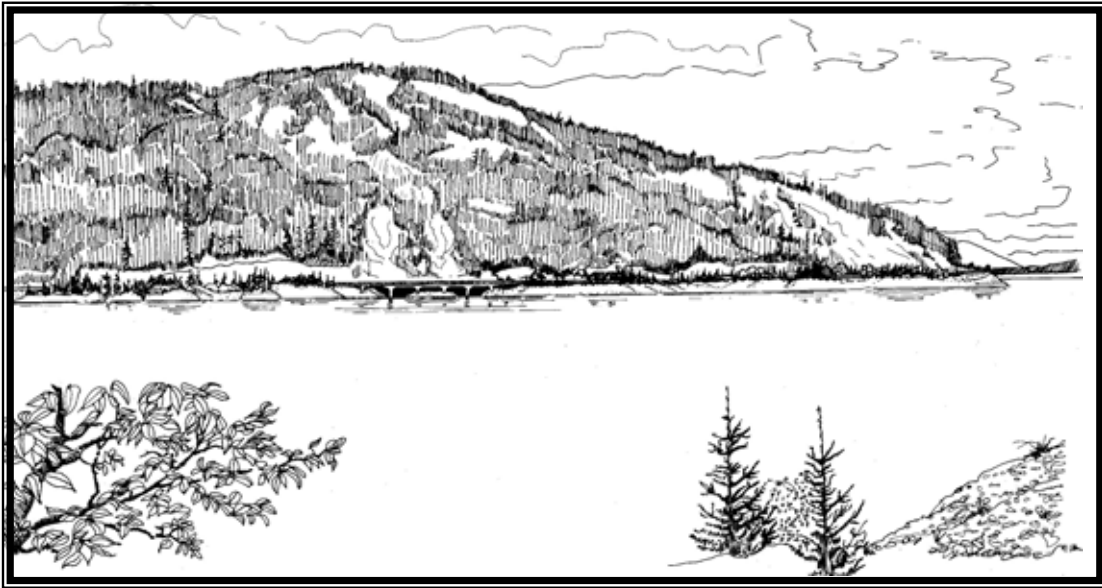
Figure 140 Key View E after Mitigation

With the restoration of the native forest community, this alternative will be blended into the existing forest. The tunnel portals can be blended into surrounding rock using colored concrete or stains. Bridges built over the rock chutes will have the arched Cascadian design theme to carry a common rhythm throughout the corridor. The concept for this alternative is seen in Figure 140.

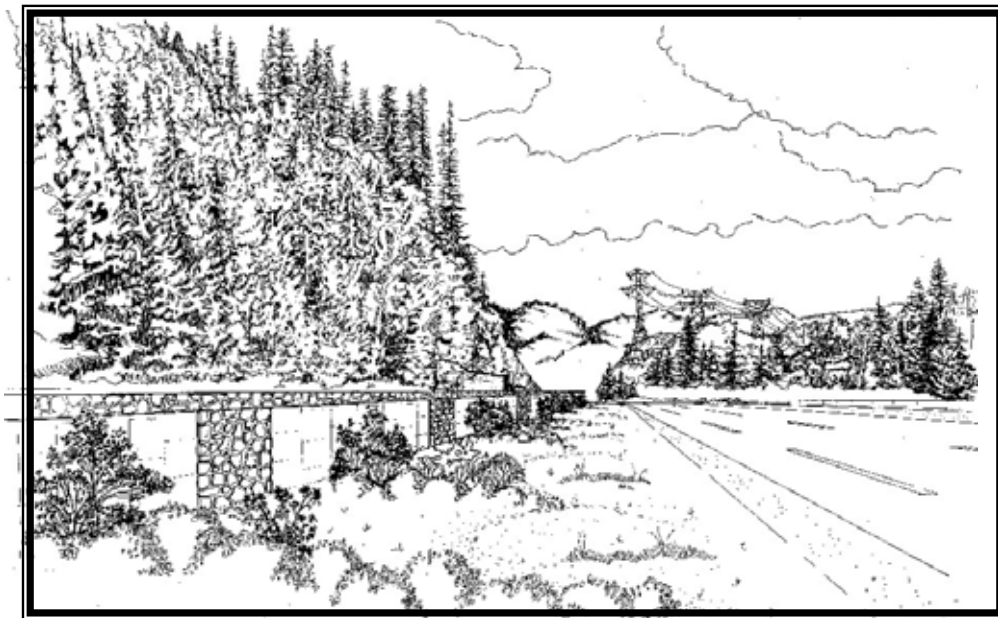
Figure 141 Concept for Retaining Walls after Project Completion & Plant Establishment

Retaining walls will be designed using the Architectural Guidelines for this project. The median will be planted with shrubs to soften the face of the wall, and to provide visual interest and color. The concept for retaining walls is seen in Figure 141.

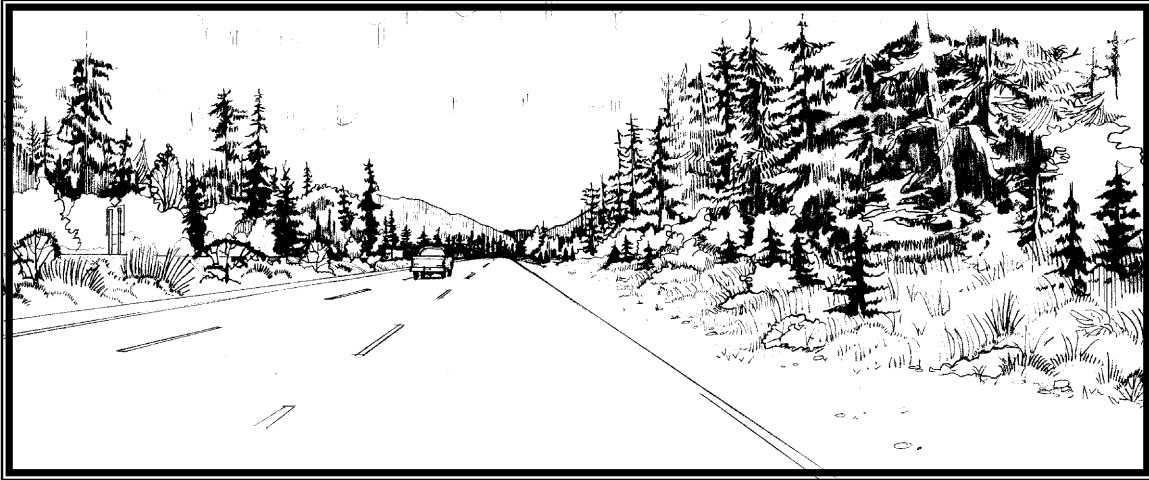
Figure 142 Key View 8 Concept

Figure 142 shows an artist's concept for the vicinity of MP 61.75 in Landscape Unit 2. It shows a forest community on the roadside and a median with shrubs.

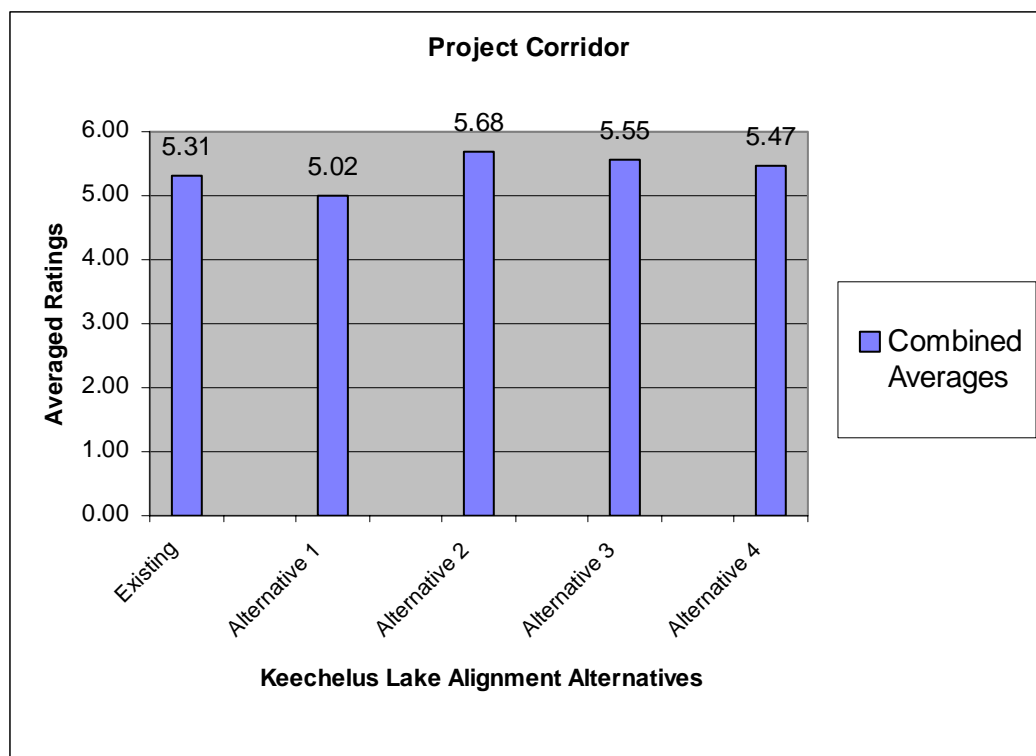
Figure 143 Comparison of Keechelus Lake Alignment Alternatives

For the four Keechelus Lake Alignment Alternatives, Alternative 2: the Short Tunnels alternative has the highest visual quality ratings. The existing roadbed would not be needed if maintenance activities were conducted from the Hyak Maintenance facility, and fewer structures would be needed for ventilation of a smaller tunnel system than for the Long Tunnel Alternative. Alternative 2: the Short Tunnels would remove the road from the sight of viewers across the lake while minimizing the amount of time travelers on the highway would be in a tunnel. While ratings for views toward Alternative 1: Long Tunnels are very high because 1.9 miles of the existing roadbed would be removed, ratings for views from the road are very low for the time the traveler is inside the tunnel. This lowers the overall rating significantly.

Ratings for Alternatives 3 and 4 are very close to one another, and to Alternative 2. Alternatives 3 and 4 both retain I-90, with its views of the lake, around Slide Curve. Alternatives 3, and 4 have larger footprints than Alternatives 1 and 2. This decreases the opportunity for plantings to buffer and screen I-90 from views toward the road. Figure 143 provides a graphic comparison of the total average visual quality ratings for each of the Keechelus Lake Alignment Alternatives compared to the Existing Condition. Only Alternative 1 has ratings below the existing condition because of the views from the road while in the tunnel.

These graphs and averages show ratings for all views from and toward the road. They provide a general basis for comparison. Details are found within each Key View description.

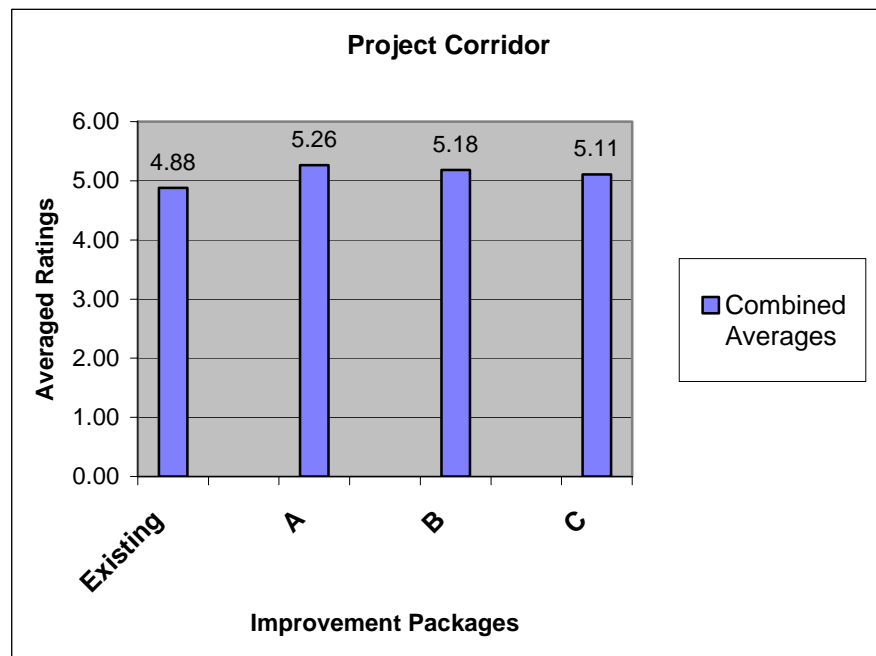
Figure 144 Comparison of Improvement Packages for Entire Project Corridor

Where there are Improvement Package options for ecological connectivity, Improvement Package A has the highest visual quality ratings because of the opportunity for increased vegetation and the use of the Architectural Guidelines on bridge railings and bridge piers. All improvement packages are very close in visual quality averages and rate higher than the existing condition. Figure 144 shows the overall averaged ratings of the three Improvement Packages and their relationship to each other.

Although the overall averages of each Improvement Package shows Option A to have the highest ratings, at some locations there are equal visual quality ratings for two options. For example, Improvement Packages A and B remove the pavement at the Price Creek Sno-park and restore native vegetation there. This results in equal ratings for Options A and B at that location. Increases in the opportunity for planting native vegetation raise visual quality ratings. Tables in Section 7 give the ratings for each Improvement Package Option at each Key View.
